## Historic, archived document

Grays Harbor, Wn.

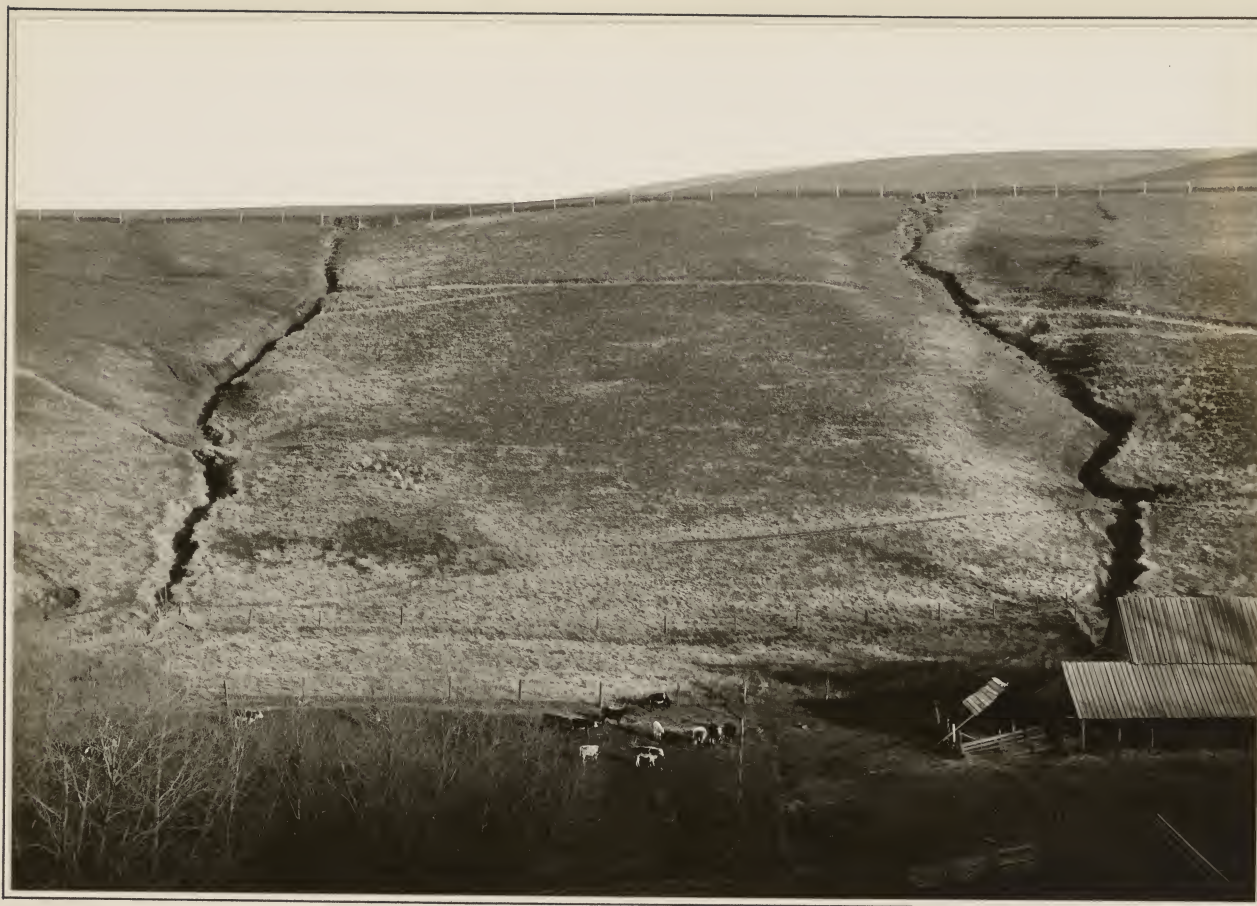
6-67 - Pullman, Washington  
EROSION - Gully

Gully erosion two miles above Morengo Wash. The field on which the gullies are now seen was once under cultivation but necessarily abandoned. The run-off and sheet erosion from lands above this field have started and developed the gullies shown. February 2, 1934.

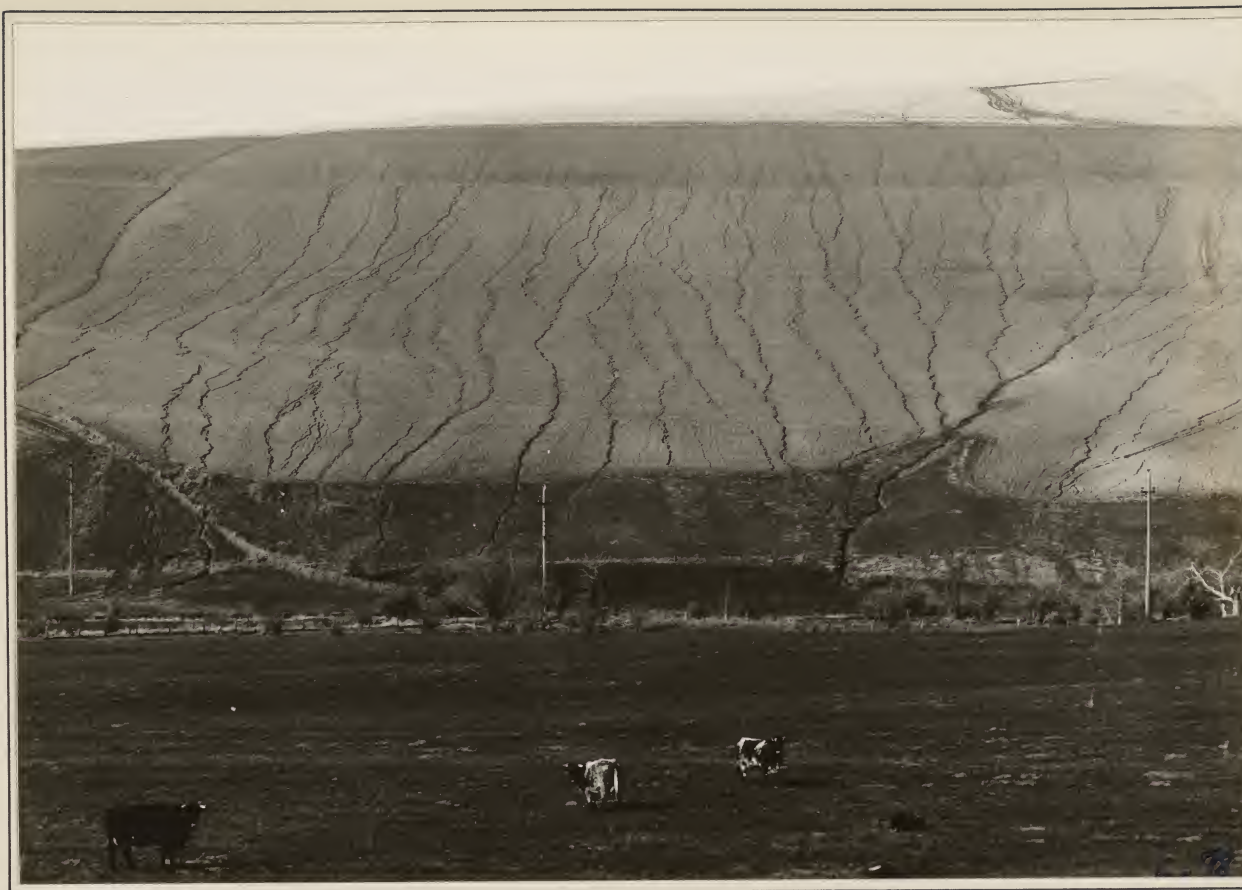
6-78 - Pullman, Washington  
EROSION - Sheet

Sheet erosion in the Patit Valley north and east of Dayton. Sheet erosion after summer-fallow erosion is starting real gullies. Tremendous soil losses occurred from this unprotected summer-fallow during the present winter. Note that harrowing operations have already been begun in the upper part of the field but have failed to completely obliterate the evidences of erosion. February 3, 1934.

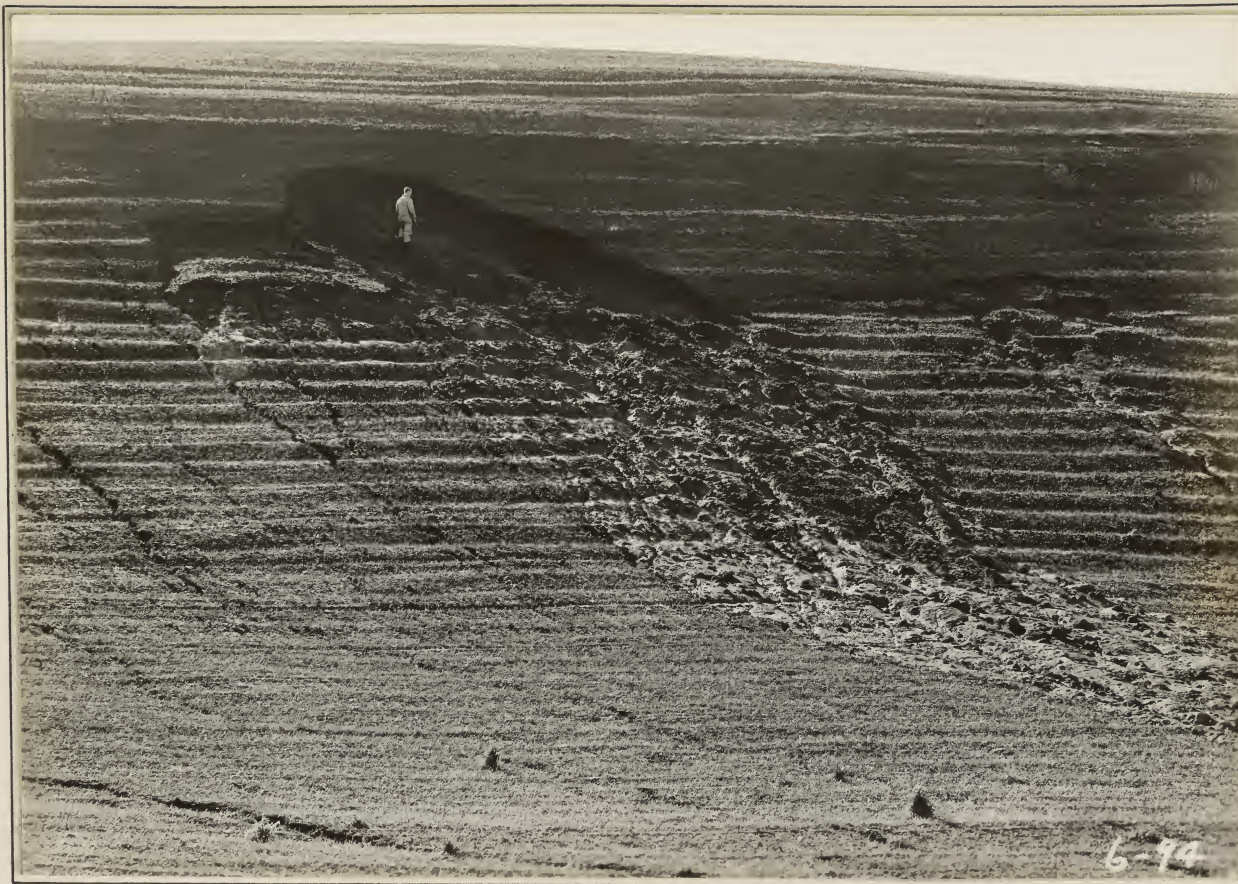
6-94 - Pullman, Washington  
EROSION - Soil Slip

On Roscoe Cox farm north of Pullman, Whitman County, Washington. This is 42 inches deep, and 50 feet in diameter. It went out on December 22, 1933. 63% northeast slope. Such land should be seeded to permanent vegetation. February 3, 1934

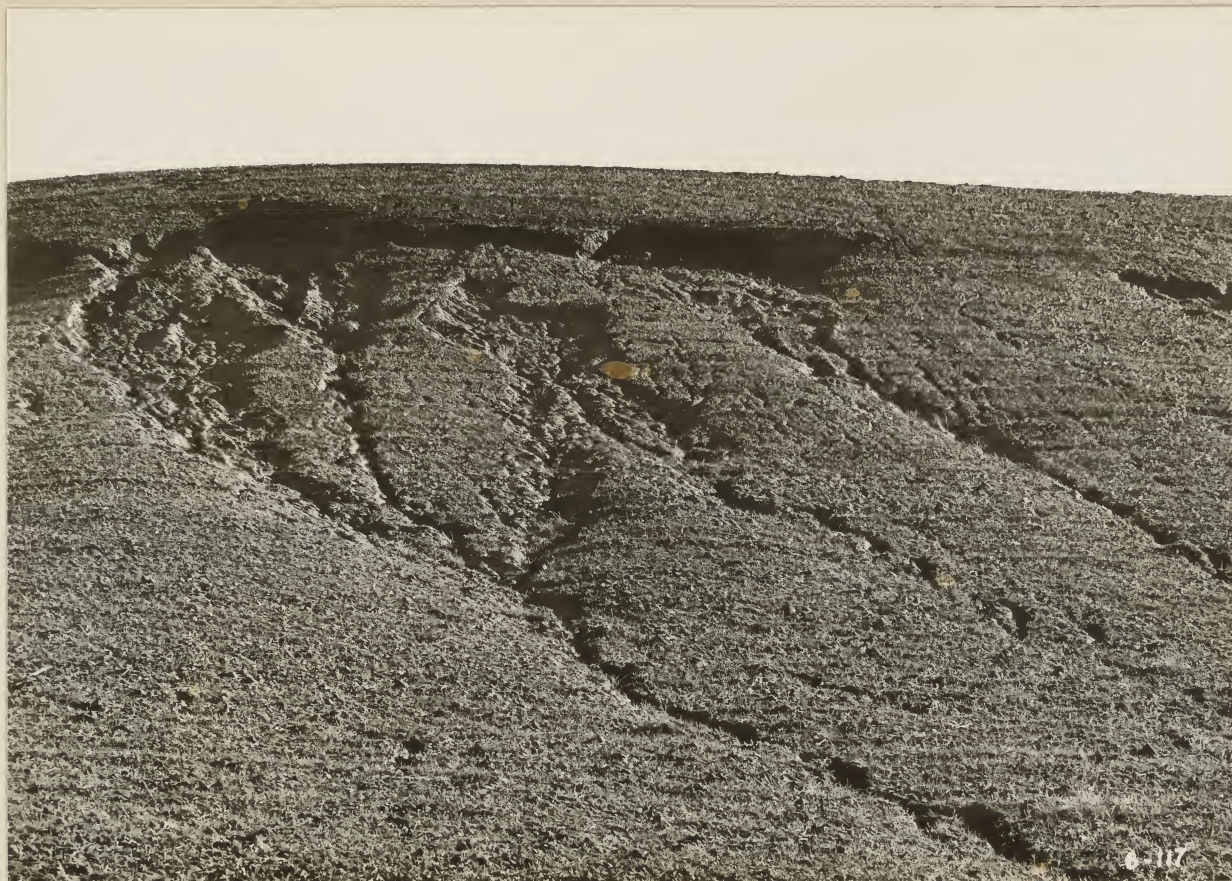
6-117. Washington.  
EROSION - Sheet.

Soil slip on Ben Druffel farm, Whitman County, Washington. This soil slipped out during the month of December. The slope gradient was between 50 and 60 percent. Such slips should be seeded to permanent vegetation. 2/20/34.

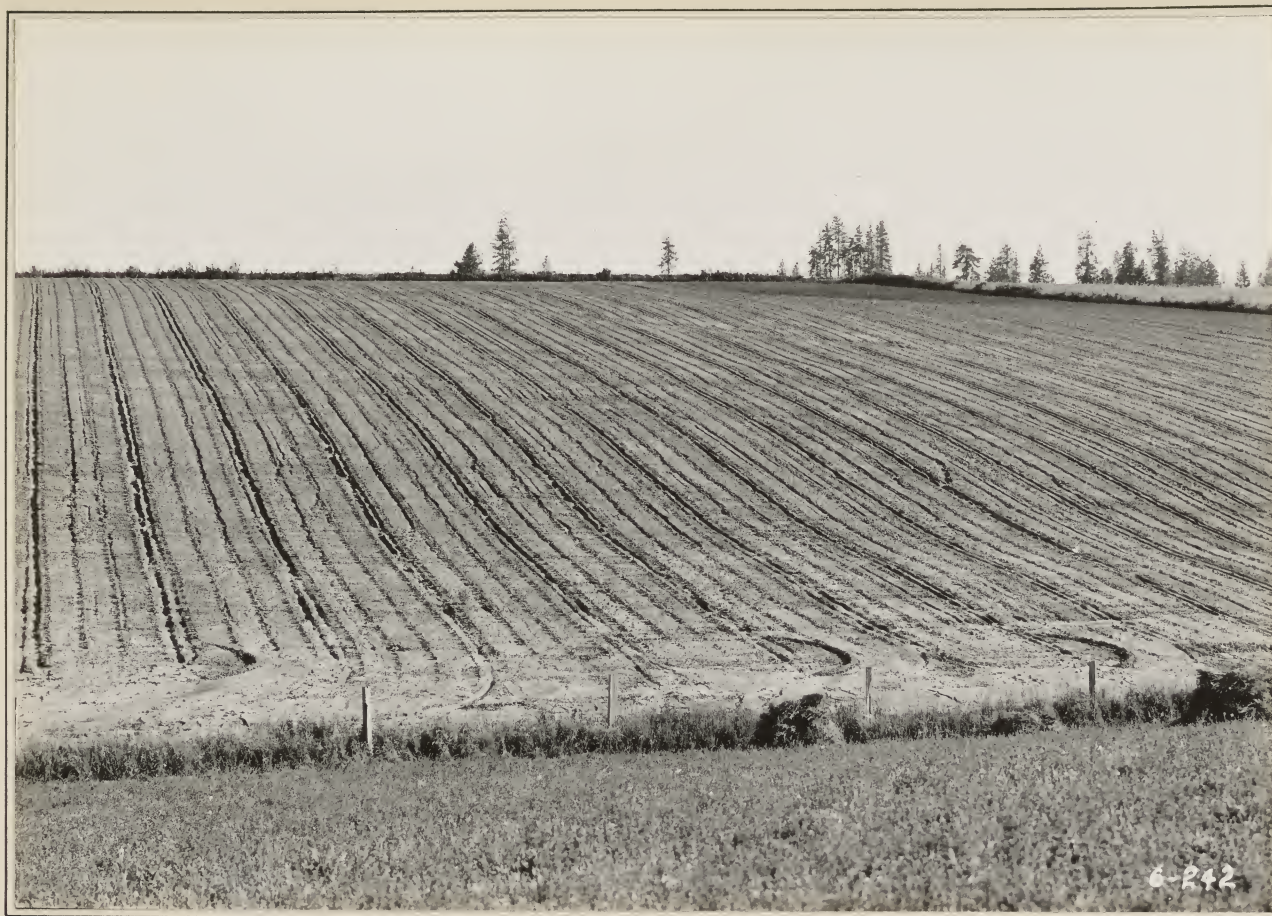
6-242 - Pullman, Washington  
EROSION - Sheet

Erosion on a bean farm south of Troy, Idaho. Rows running up and down hill greatly aggravate soil losses.

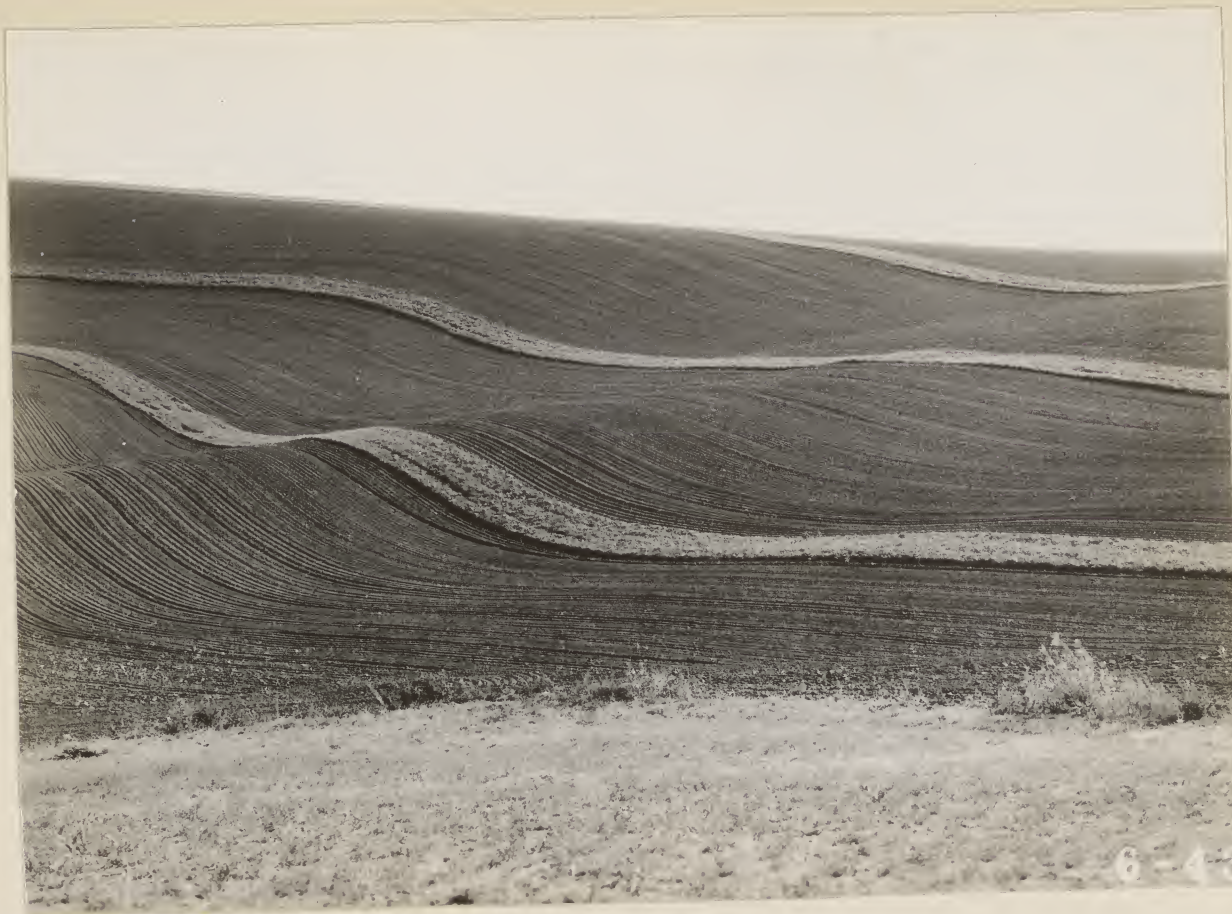
6-436 - Washington.  
EROSION CONTROL - Strip Cropping.

Close up of field shown in 6-442. These strips were seeded one ten foot drill width wide with SES drill. The seeding was finished about a month before this was taken. July 19, 1934. A. L. Hafenrichter.

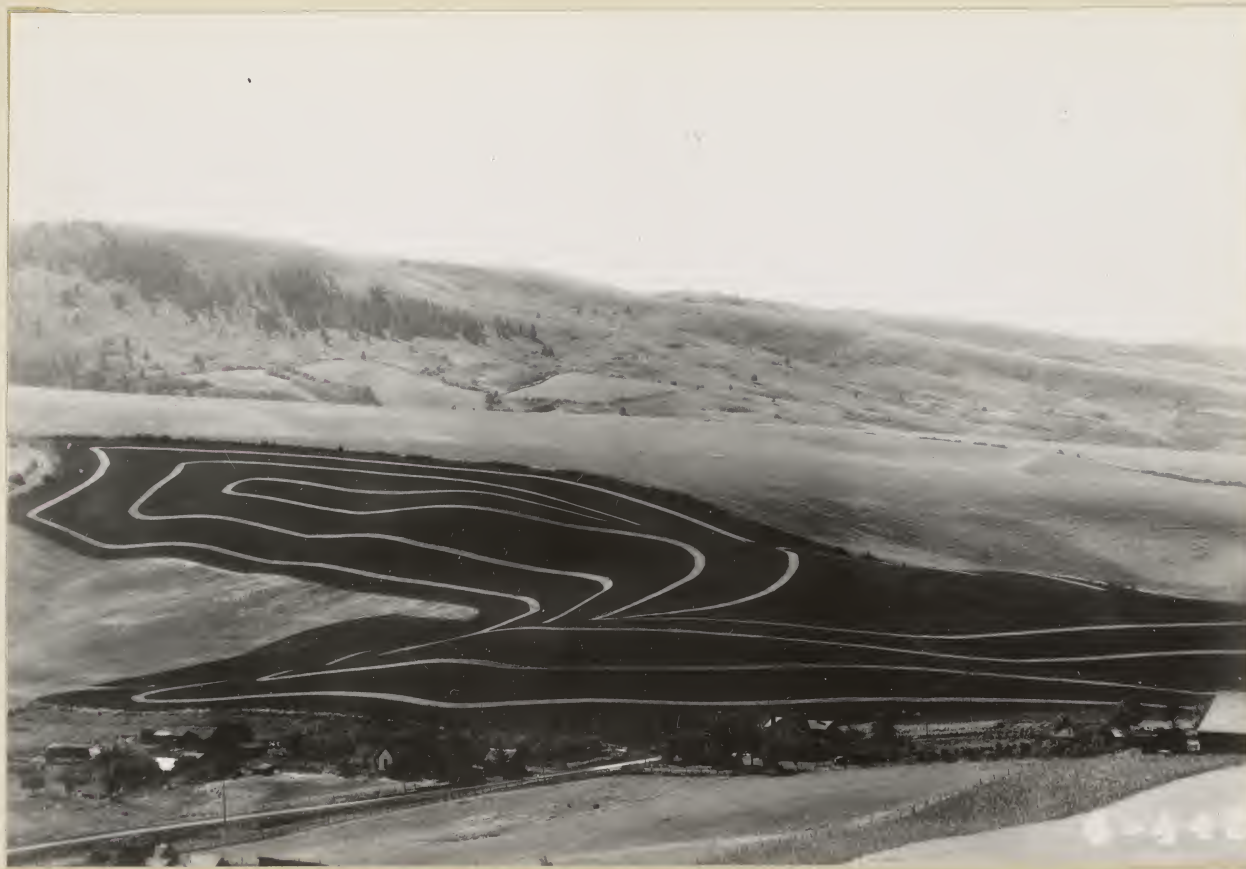
6-442 - Washington.  
EROSION CONTROL - Contour Cultivation.

Strips of winter wheat seeded on the contour in a summer fallow field on the Arthur Snow farm a mile and half south of Moscow. This method is effective in retarding the down wash of soil on moderate slope.

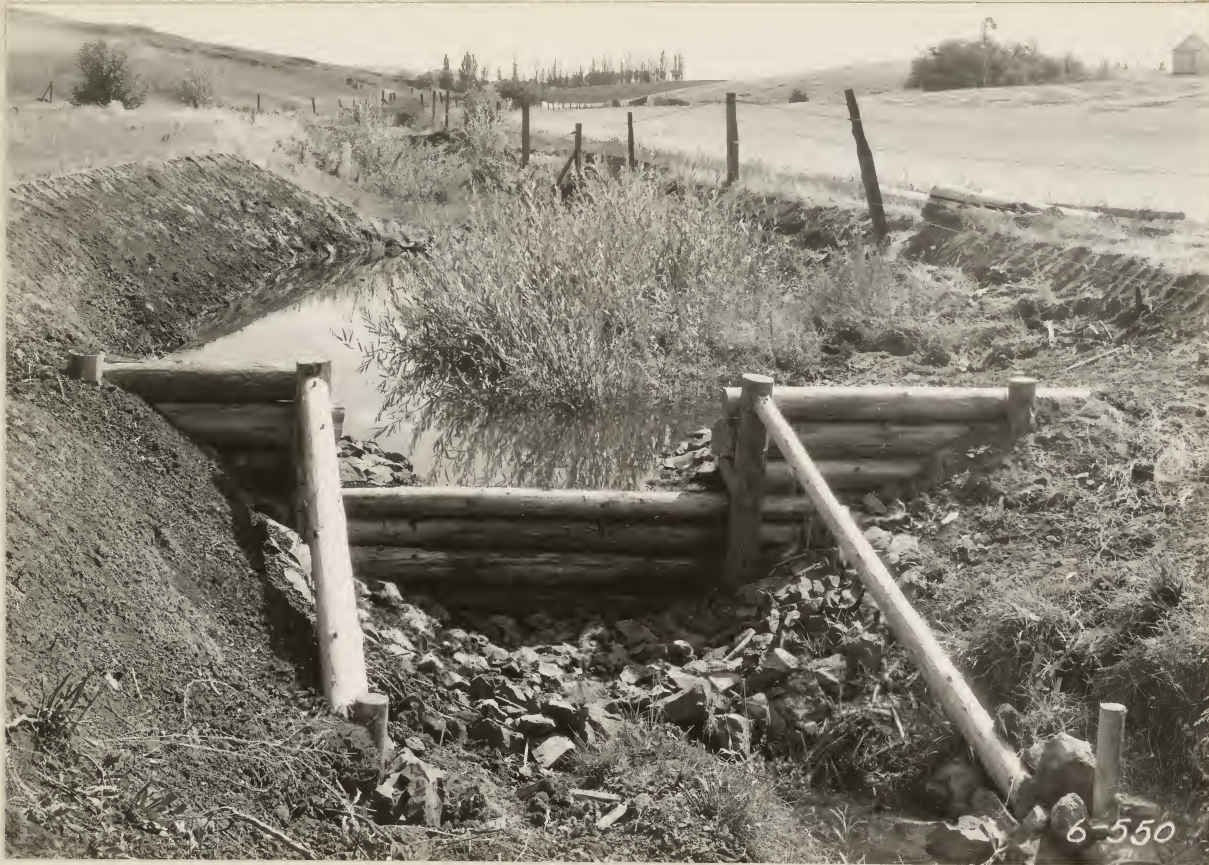
Washington-6-550. Whitman county. September 1934. Log check dam in large gully on Tom Prichard place.

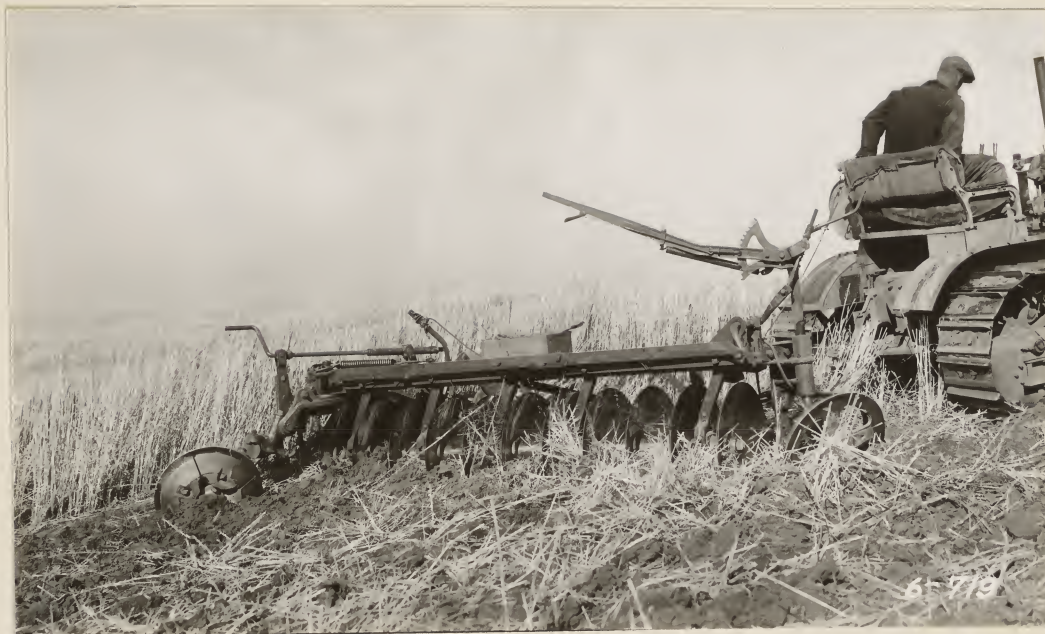
6-719 - Washington.  
MACHINERY.

Plowing with disk plow in heavy wheat stubble. Fred Wexler farm.

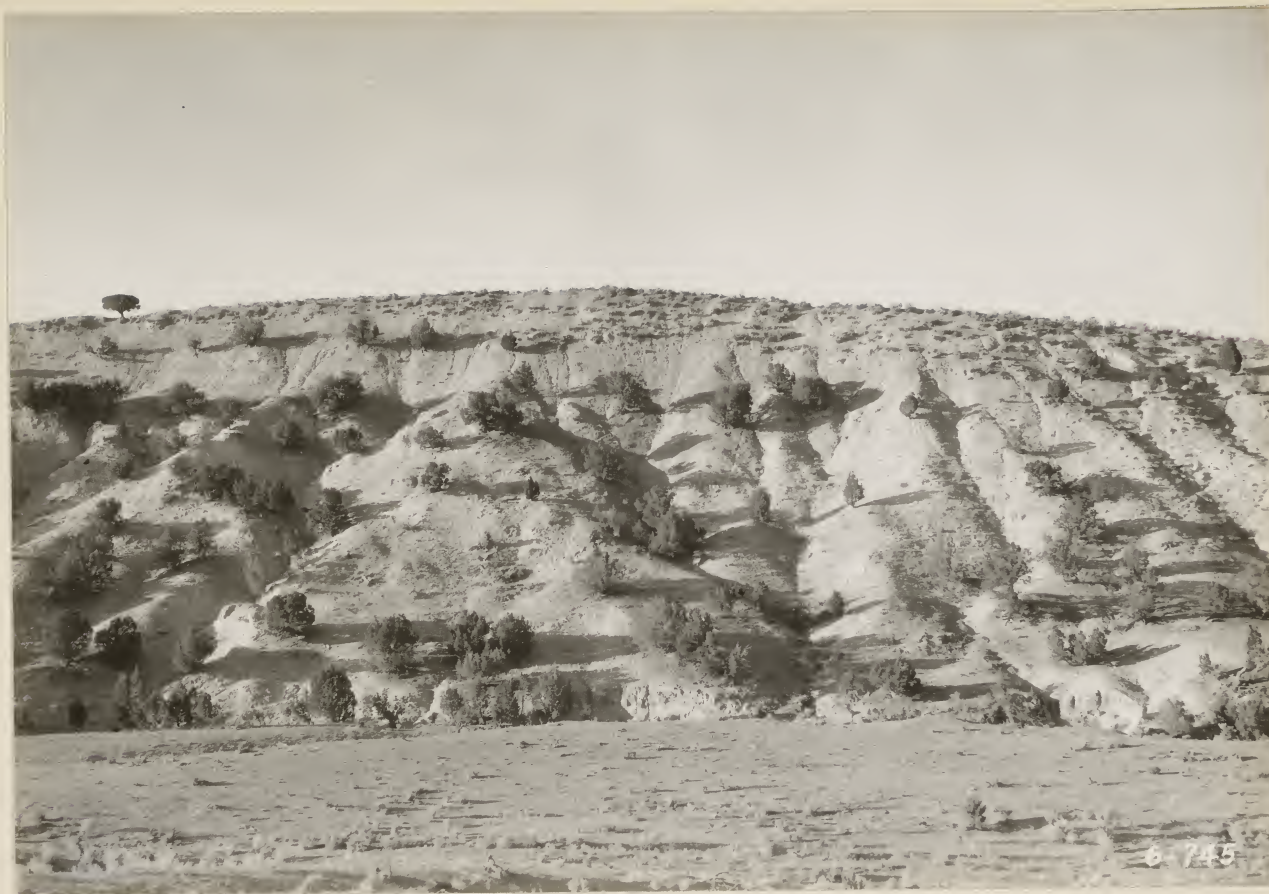
6-745 - Pullman, Washington.  
EROSION - Gully.

Serious gully (No. 9) on badly overgrazed range land near American Falls, Power County, Idaho. The gully at the bottom of the hill was over 20 ft. deep. This land was once covered by a good stand of bunch-grass. 9/29/34.

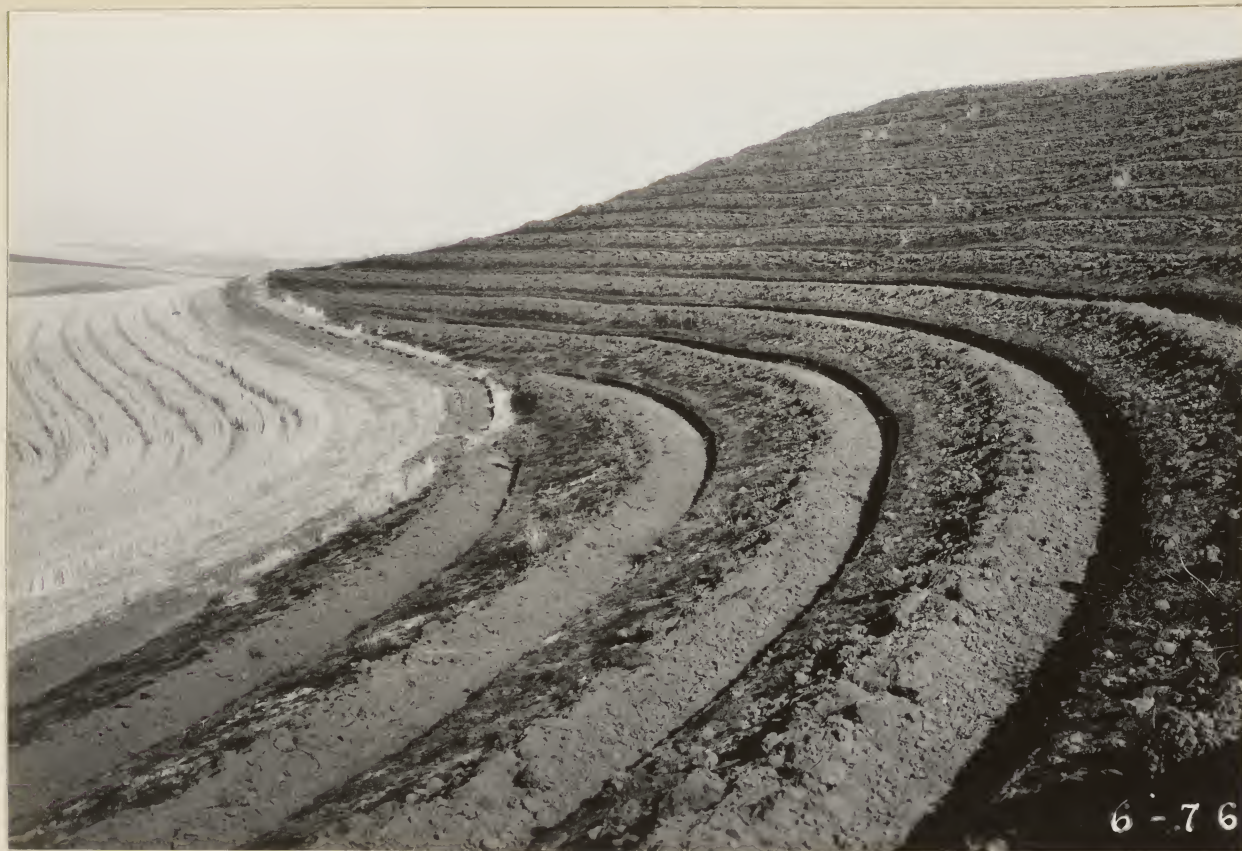
6-762 - Washington.  
EROSION CONTROL - Terraces.

Terraces on a steep N hillside of the Leonard Brown farm. These terraces were made with an especially constructed tractor drawn gang plow and were finished with a grader. Trees will be planted in these terraced channels. Sec 18 /T 14 N R 46 E. Whitman Co. Oct. 5, 1934. A. L. Hafenrichter.

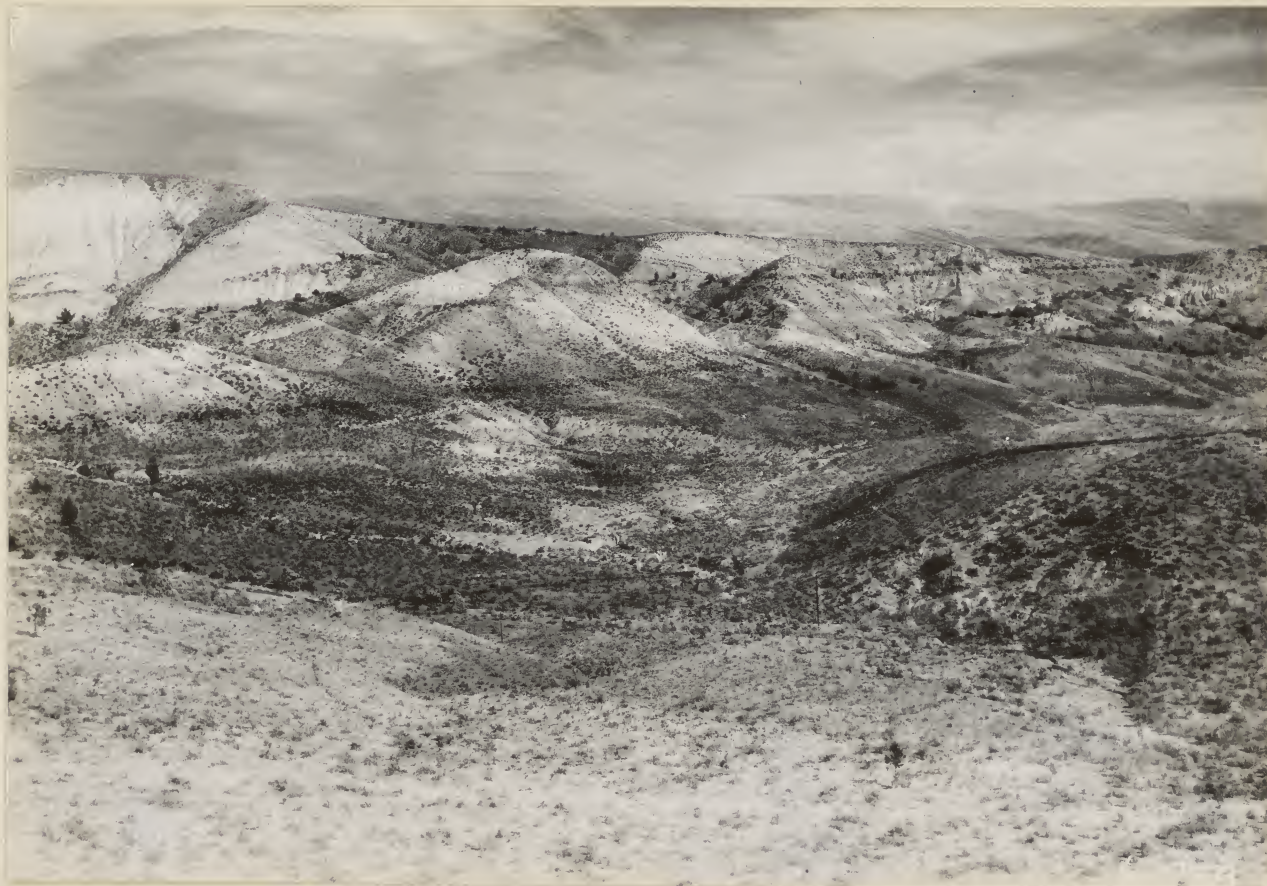
6-758. Oregon.  
EROSION - Gully.

Serious gullying on grazing land at Durkee, Baker County, Oregon.  
This land could all support an abundant bunchgrass cover. It has been  
ruined by overgrazing. October 2, 1934. Photo by A. L. Hafenrichter.

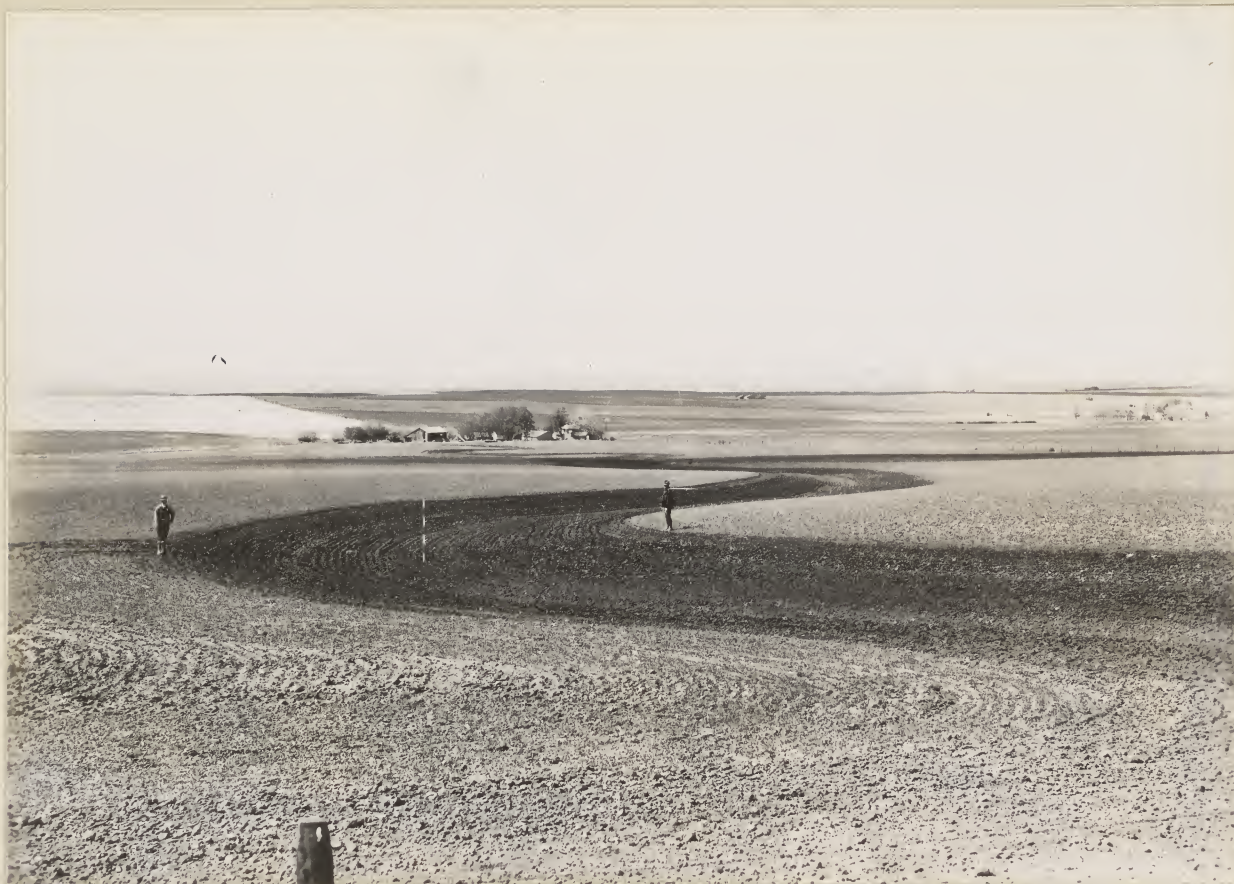
6-1124. Oregon.  
EROSION CONTROL - Gully Control.

A graded-in gully on the Wildhorse project near Athena, Umatilla County, Oregon. Low check dams were placed in the gully before the grading work was done; the spring-tooth harrow was used to smooth down the ground. The seed bed will be prepared and the entire water course seeded to perennial grasses. March 23, 1935.

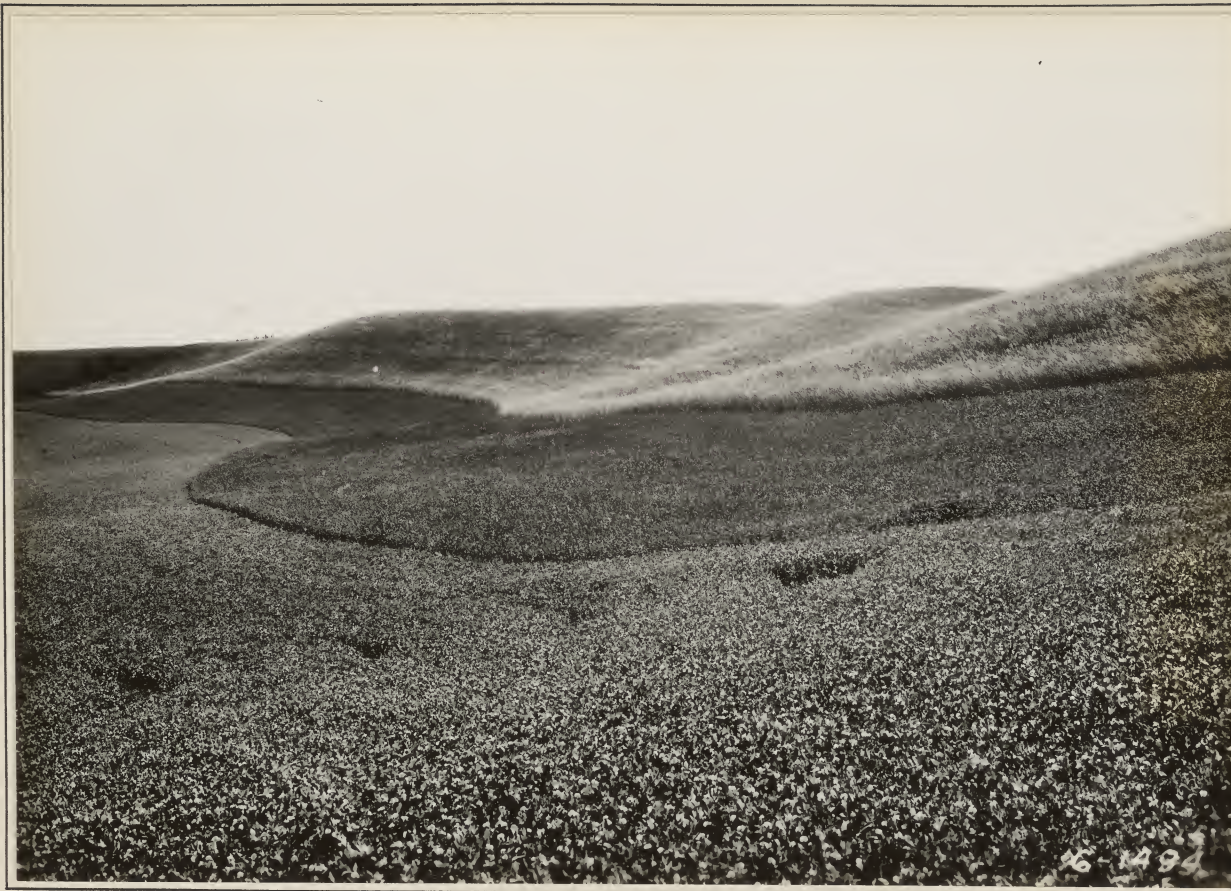
6-1494 - Pullman, Washington  
EROSION CONTROL - Grasses

Use of typical hill and north slope seedings on Project #6. Hilltops are eroded badly and are submarginal for wheat production. Steep north slopes average more than 40% slope gradient. Erosion from these lands is reducing the value of the lesser slopes lying adjacent to and below them. Steep lands such as shown have been dedicated to permanent seedings of alfalfa and grasses. When dedicated to this new use, erosion is adequately stopped and run-off is greatly reduced. This mixture of grass yielded approximately two tons of hay per acre. June 13, 1935

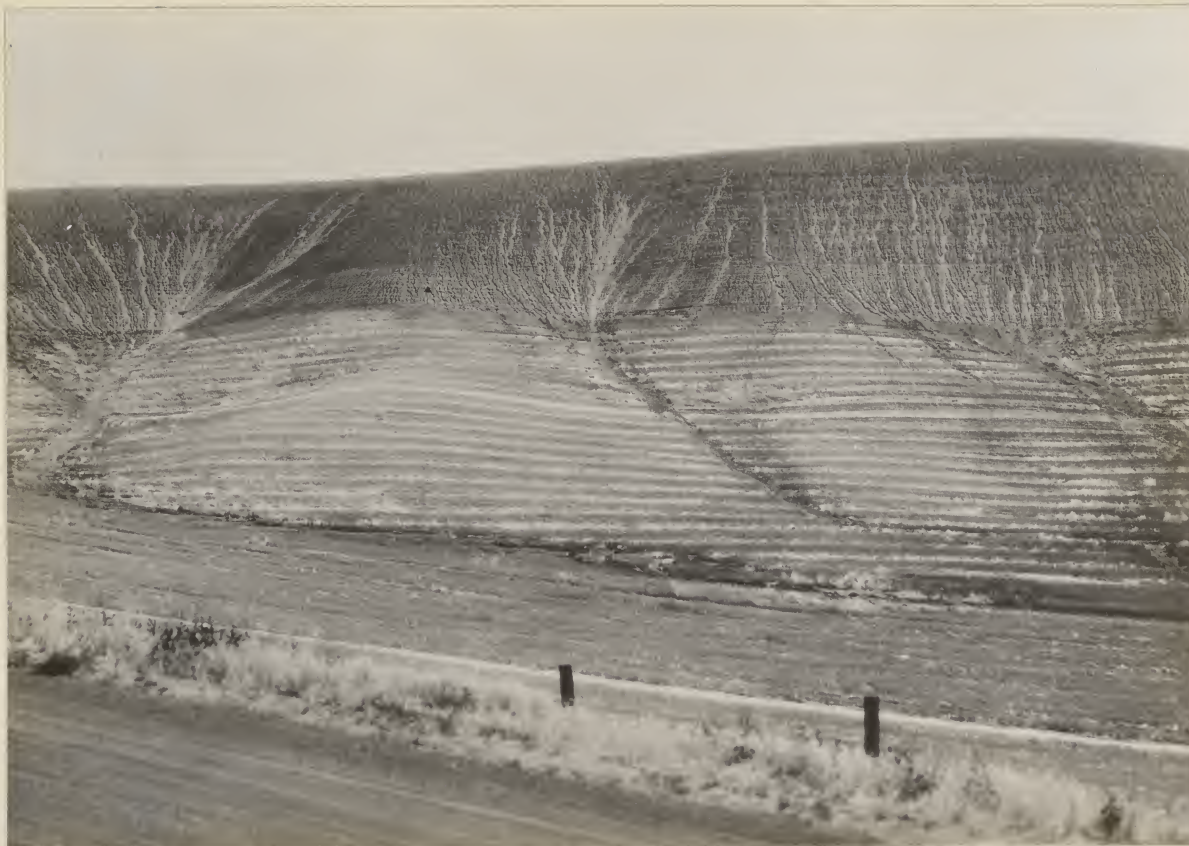
45-2.<sup>NB</sup> Washington.  
EROSION - sheet.

Upper slope is summer-fallow and lower slope is wheat stubble where wheat was cut just a few days before rain of July 30, 1931. The erosion on the wheat stubble was slight except where the concentrated runoff from the summer fallow crossed the corn at these points. The erosion was only a surface wash with much less depth than on the summer-fallow above.  
Whitman County. August 1, 1931.

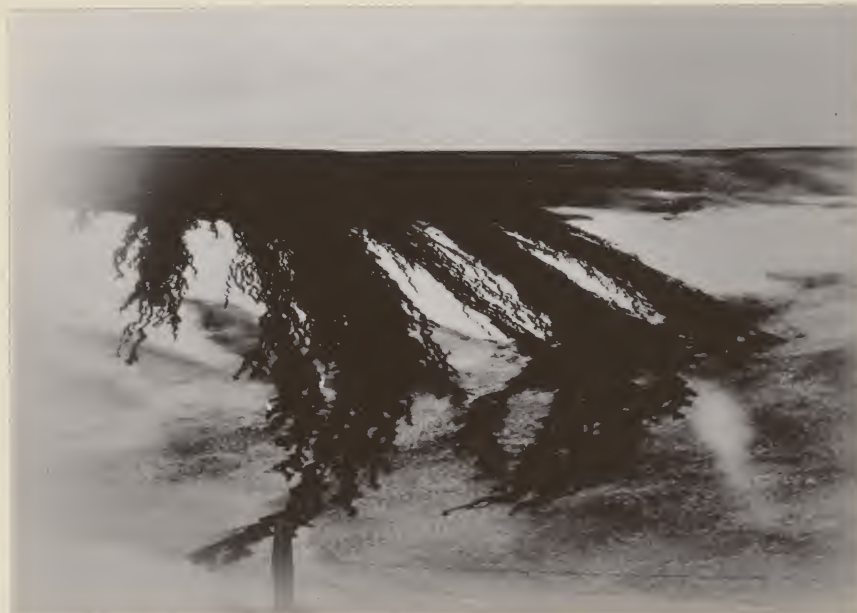
45-34 - Washington

The braiding in this picture is dark soil washed from bare ground above and deposited over accumulated snow below. Palouse Wheat Belt.

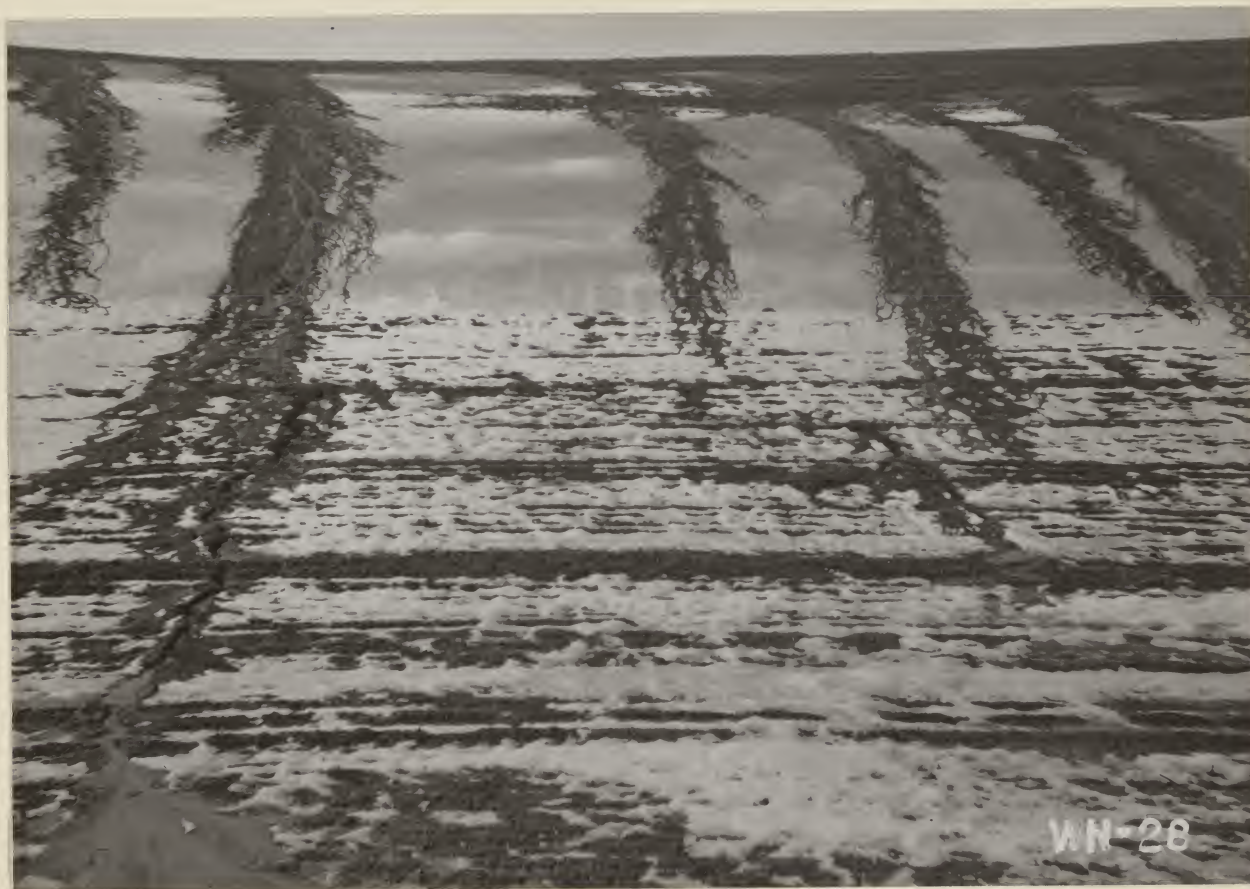
WN-28

This picture shows sheet erosion on top of the hill, with silt deposits on frozen drift. The soil above and below the drift is thawed out. Four miles southwest of Pullman, Sec. 21, R. 45E, T. 14N.

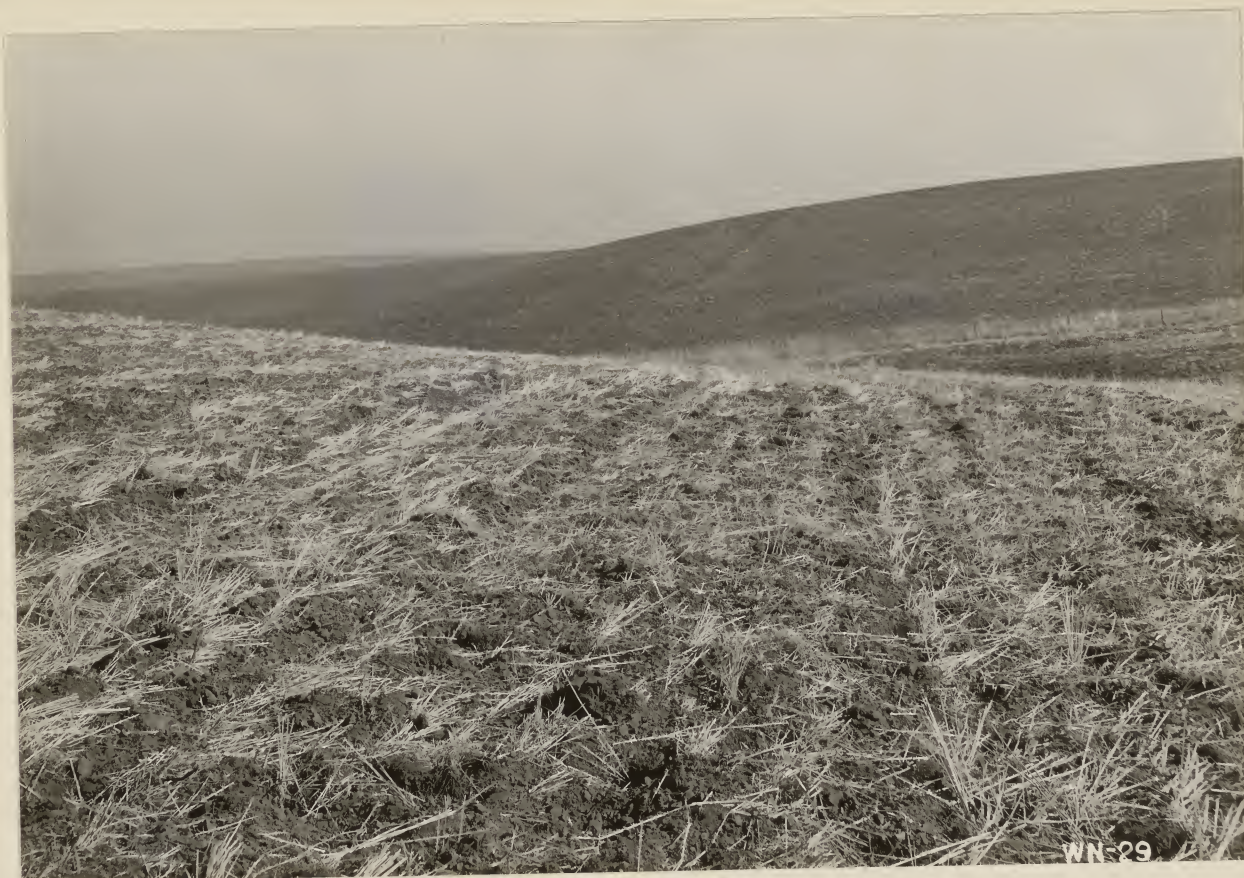
Wn-29. Washington.  
FARMING.

This picture shows winter wheat stubble disk-tilled September 1936  
with a John Deere 26" disk tiller. George Swales farm,  $1\frac{1}{2}$  Mi. North  
of Johnson, Whitman County, Washington. 10/10/36.

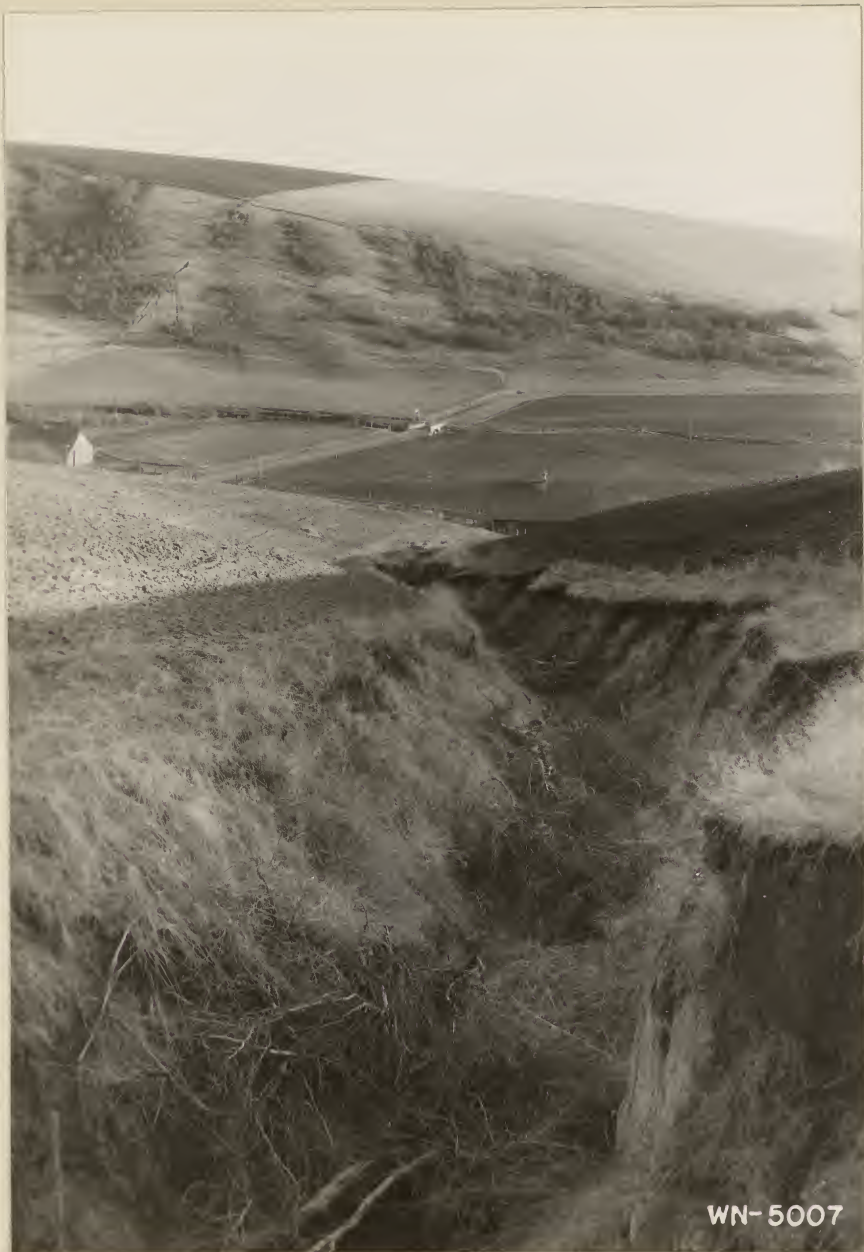
WN-5007

Field gully which is the result of continuous summer-fallow-winter wheat farming in the adjoining fields.  
C. J. Broughton farm,  $1\frac{1}{2}$  miles northeast of Dayton, Columbia County, Washington.

This is an after picture of Broughton Gully. The gully was sloped by hand labor and grader, then seeded to alfalfa, grass, and locust trees. See before picture Wn-5007. One mile east of Dayton, Columbia County, Washington.  
10/29/36.

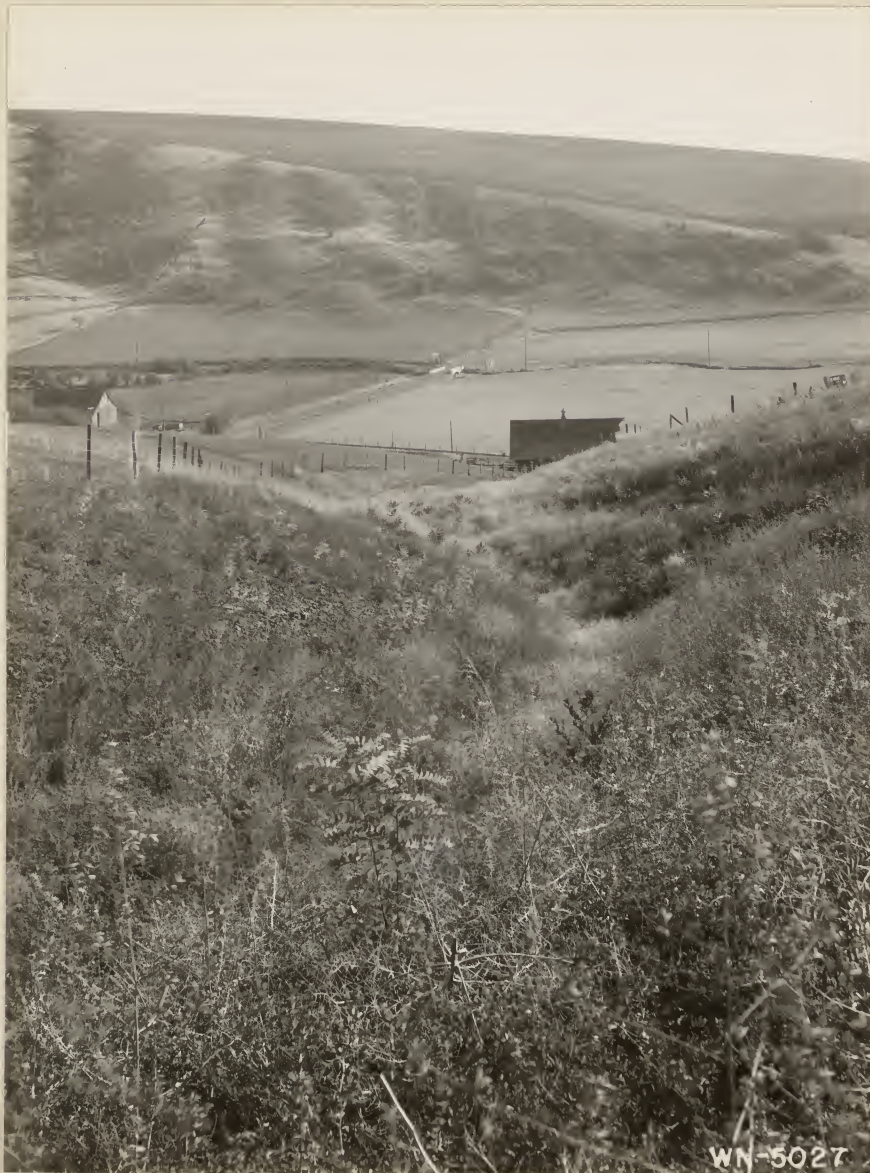
Wn-5027. Washington.  
EROSION CONTROL - Gully Control.
